Use Attainability Analysis  
for  
WBID 3251 Big Sugar Creek

Submitted by  
SES, Inc.

To  
Missouri Department of Natural Resources  
Water Protection Program

**Field Data Sheets for Recreation Use Stream Surveys**  
**Data Sheet A - Water Body Identification**  
(For water body being surveyed)

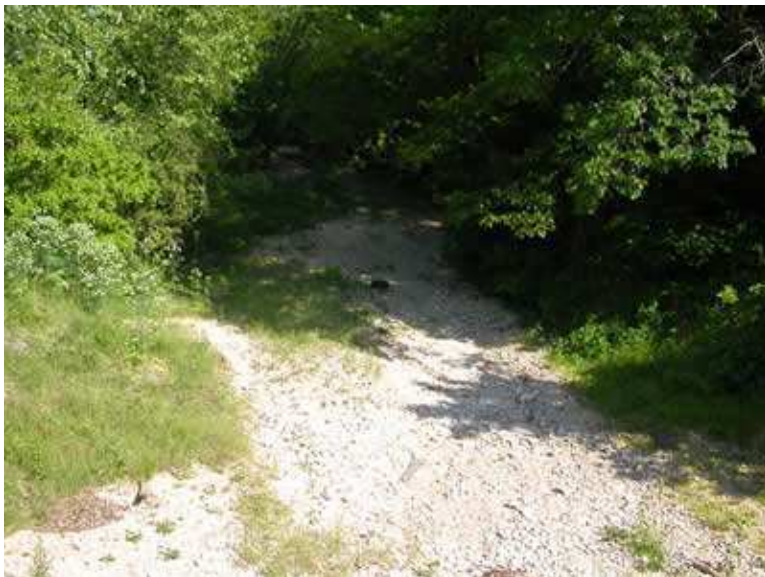
**Site# 1 Photo ID# 93, Downstream**

**WBID #** 3251      **Site #** 1  
**Mark #** 47      **Dissolved Oxygen (ppm)** n/a (Dried up)  
**Upstream Views Physical Dimensions:** Is there any water present at this view? no  
 If so, is there an obvious current? no

**Downstream View's Physical Dimensions:** Is there any water present at this view?

Substrate:

50% Cobble	50% Gravel	% Sand	% Silt
------------	------------	--------	--------

Vegetation in the dried stream bed

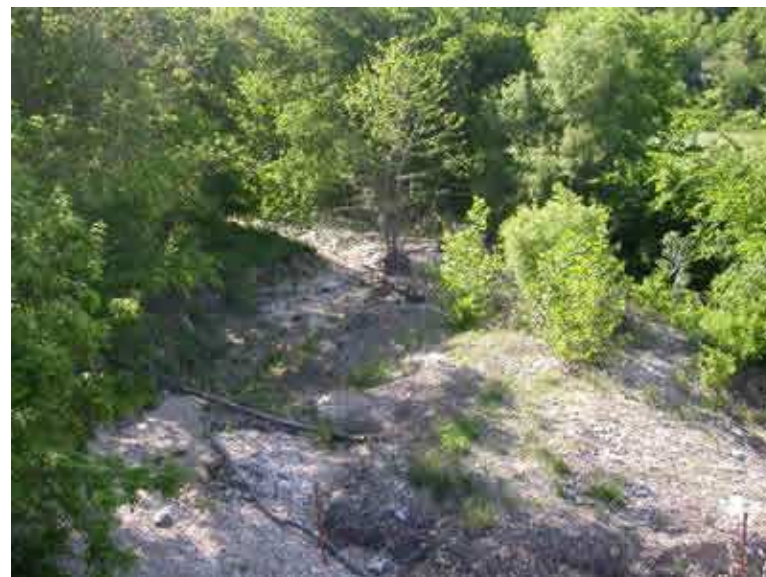
**Site# 1 Photo ID# 92, Upstream**

% of Channel Feature				
Riffle	n/a				
Run	n/a				
Pool	n/a

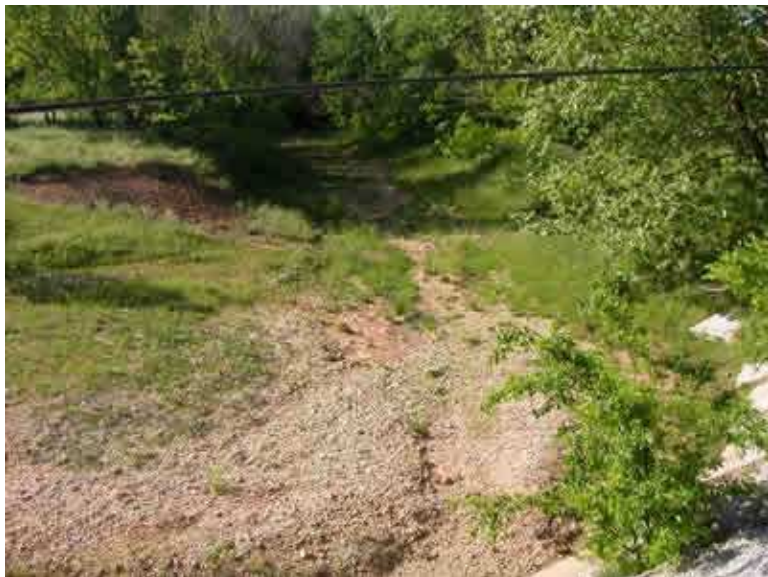
**Site# 2 Photo ID# 95, Downstream**

**WBID #** 3251      **Site #** 2  
**Mark #** 48      **Dissolved Oxygen (ppm)** n/a (Dried up)  
**Upstream Views Physical Dimensions:** Is there any water present at this view? no  
 If so, is there an obvious current? no

**Downstream View's Physical Dimensions:** Is there any water present at this view?

Substrate:

50% Cobble	50% Gravel	% Sand	% Silt
% Mud/Clay	% Bedrock

Vegetation in dried stream bed

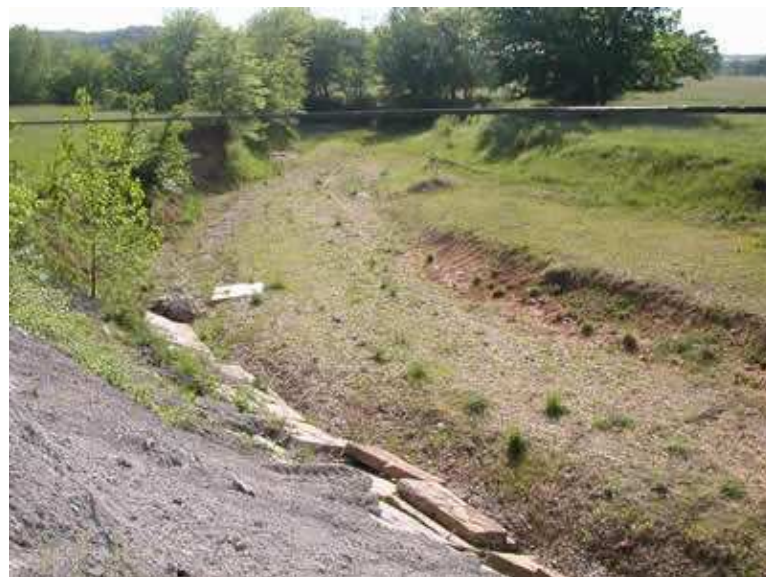
**Site# 2 Photo ID# 94, Upstream**

% of Channel Feature				
Riffle	n/a				
Run	n/a				
Pool	n/a

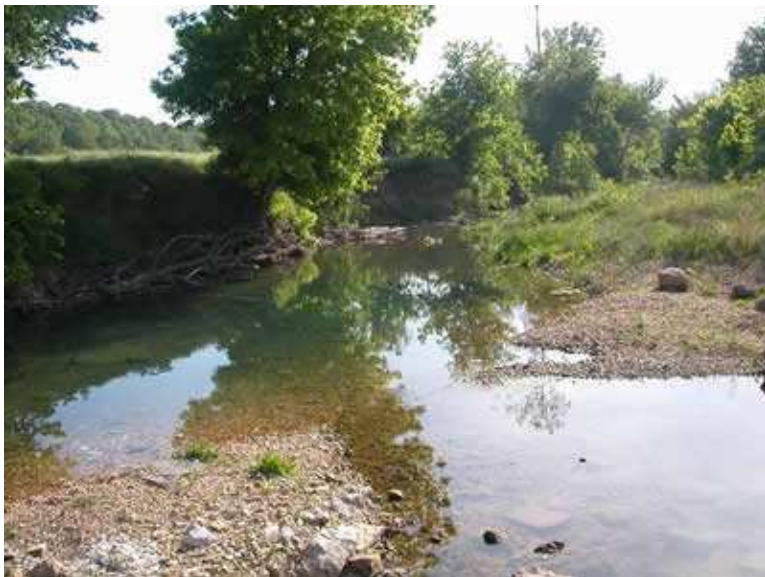
**Site# 3 Photo ID# 96, Downstream**

**Downstream View's Physical Dimensions:** Is there any water present at this view?

Substrate:

40% Cobble	40% Gravel	0% Sand	20% Silt
------------	------------	---------	----------

Vegetation in dried stream beds, algae covering submerged rocks, vegetation along banks, and some floating algae

Odor	Sewage	Musky	Chemical	<b>None</b>	Other
Color	<b>Clear</b>	Green	Gray	Milky	Other
Bottom Deposit	Sludge	Solids	Fine Sed.	<b>None</b>	Other
Surface Deposit	Oil	Scum	Foam	<b>None</b>	Other

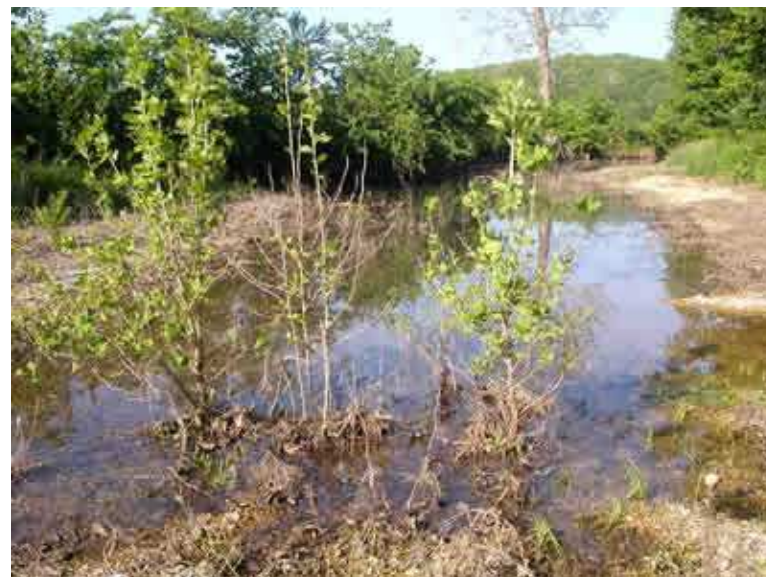
**Site# 3 Photo ID# 97, Upstream**

**WBID #** 3251      **Site #** 3  
**Mark #** 49      **Dissolved Oxygen (ppm)** 6.5  
**Upstream Views Physical Dimensions:** Is there any water present at this view? yes  
 If so, is there an obvious current? no
